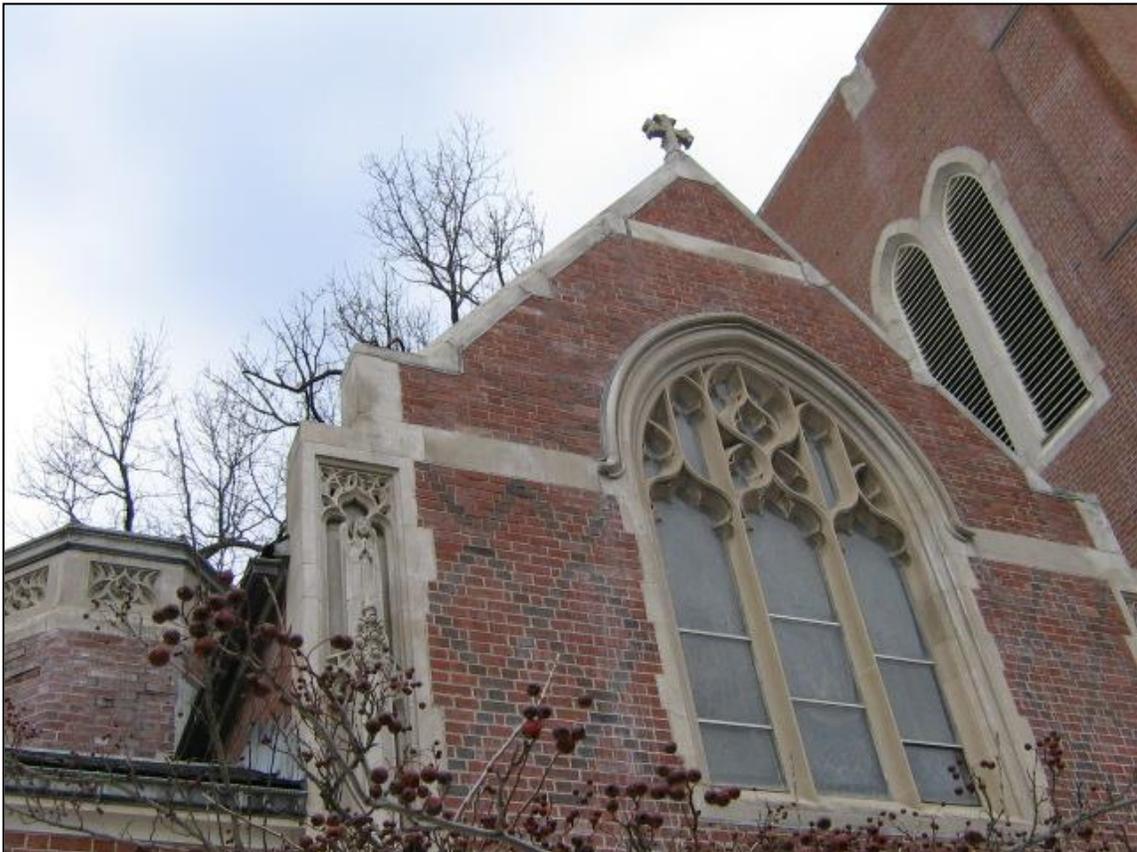
1. Failed Waterproofing

Some years ago, it appears that waterproofing was applied to most of the building exterior. In some places, it appears to have been brushed on with a roller, and in other areas it appears to have been sprayed on. Either the environmental conditions were wrong (too wet, too hot, too cold) or the product was inferior, but the waterproofing did not seem to penetrate the brick, and it turned opaque on the surface, leaving a “milky” look. My initial impression is that this can probably be removed with simple methods such as water and scrubbing.

I propose to do two or three test areas, perhaps on different brick types, and assess the likelihood of large-scale success. After that initial test, I can provide an estimate for a complete job, priced by building or elevation to give you cost flexibility.

The test patches would measure 6’x6’, and should be completed on inconspicuous surfaces. I recommend one for each type of masonry assembly: e.g. new sanctuary, chapel, school, etc. The test patches will need to completely dry for weeks before we can make any decisions. If you decided not to proceed with the work, I would charge you \$200 per test patch, otherwise there would be no charge.

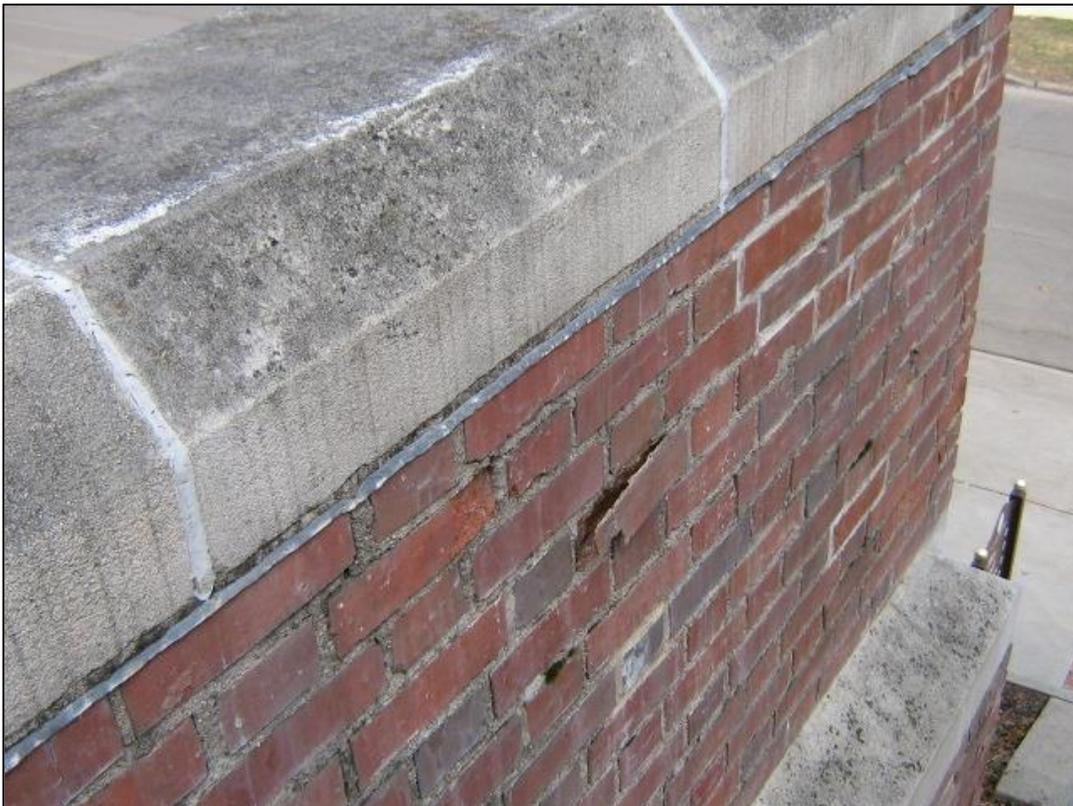
2. Moisture Damage and Spalling

The source of the moisture damage and brick spalling is not clear. Spalling is commonly the result of bricks being softer than the adjoining mortar. When I see spalling like this, I usually also see moisture problems in the building. The moisture problems need to be addressed, or the masonry repairs will fix only part of the problem.

I took a good long look at the waterproofing details on the building and I am afraid that I *don't* find any obvious source of water penetration. There are incidental areas (see below), but nothing systemic, which I expected given the extent of the damage. All of the usual details on this type of assembly are present: good caulking at the capstone head joints, a lead drip edge below the capstones, a well-detailed roof installation, etc. I am a bit perplexed.

It appears that the worst areas have been decaying for some time and have been repaired more than once. The worst area is the corner and upper corner of the Sunday School building on the southeast. There is similar incidental damage throughout the campus.

The overall design of the building is quite hard on the bricks. The design permits quite a bit of water to be able to run down the face of the wall, starting from the very top. There is no overhang to protect the top of the wall and to create a drip line away from the plane of the wall.

One other idea is that there may be space beneath the existing roof that is trapping moisture leaving the building, which is trying to get out through the bricks. We would need to investigate from inside.

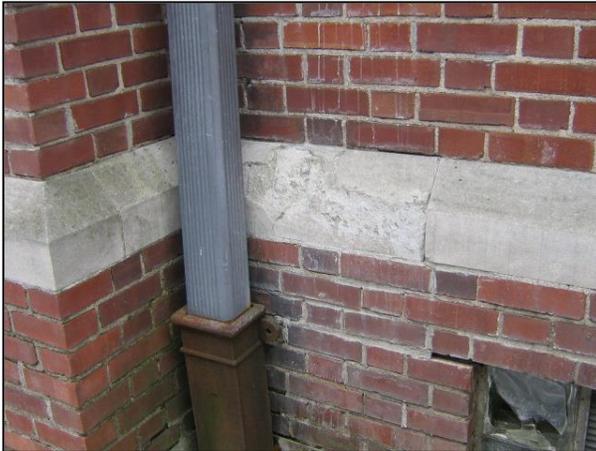
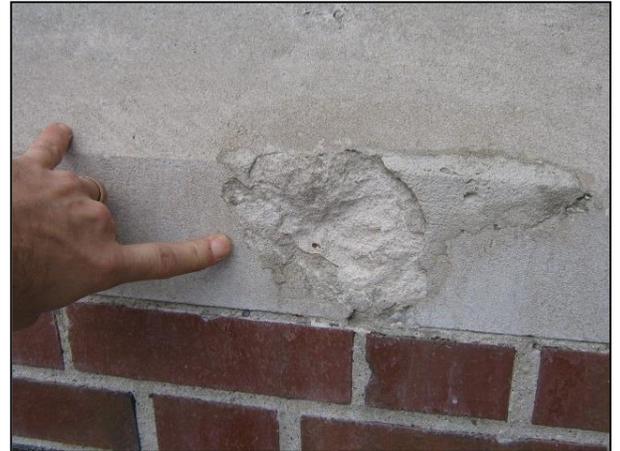
1. Stone Damage

I found two areas where the limestone water table should be patched, or replaced.

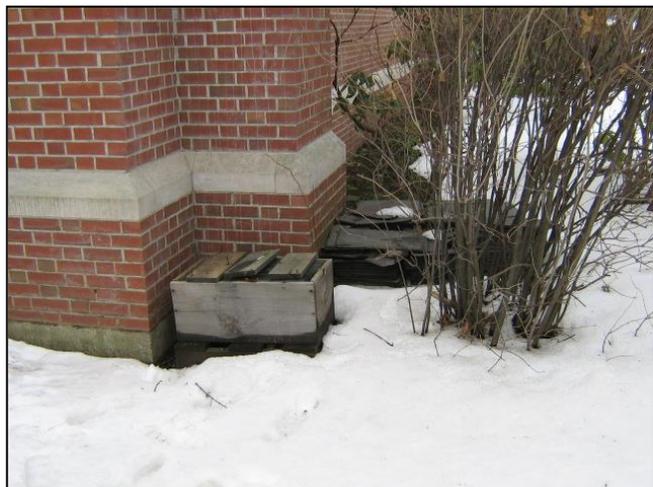
3. Slate repairs

There are 20-30 spots on the roof of the Sanctuary that need repair, including areas that were repaired with white caulk. Also, there is a supply of extra slate laying on the ground outside that should be put in storage.

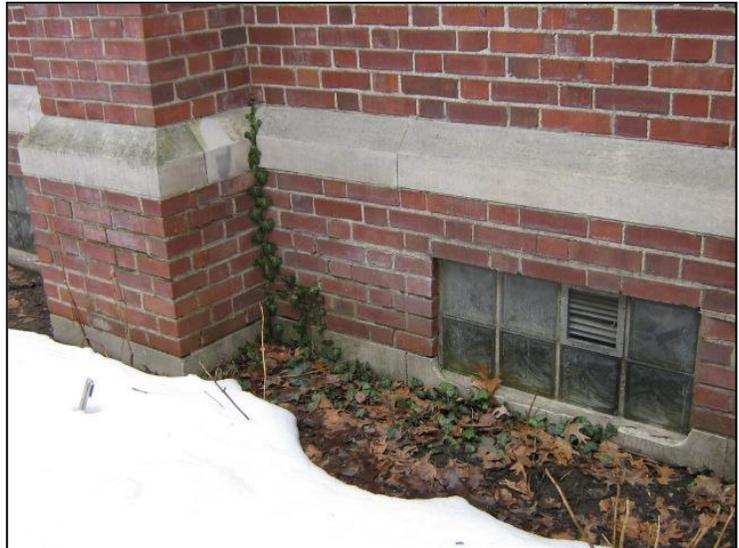
4. Miscellaneous tuckpointing

Throughout the building, but mostly on the Klise Chapel and Cloister, there are incidental areas that need to be tuckpointed. There are perhaps 20-30 such areas.
