March 6, 2014

RE: Spires on *****

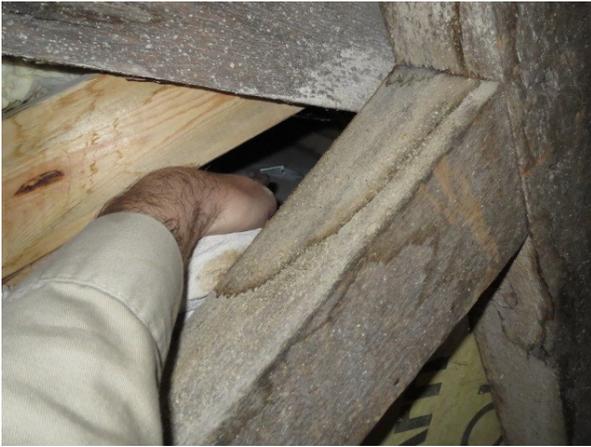
In addition to the warm moist air that comes into the spire through the hatch, there are other spots, such as this transition to the adjacent attic. All of these cracks and gaps need to be identified and closed off.

To eliminate the supply of warm moist air, each spire interior needs to be sealed off from the spaces that are warm and moist. This is a fairly simple process of using appropriate materials to weatherstrip in the same way you would any other space., including:

- Weatherstripping and insulating the hatches, as you would an exterior door
- Locating and sealing all of the various small openings and cracks inside the spire that lead to heated spaces, including attics.
- Insulation is not as important as blocking air movement into the spire from warm spaces

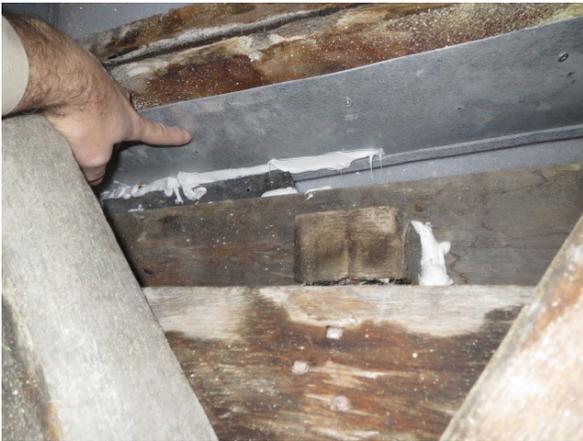
This is an example of basic repairs made to the sheet metal, probably during the roofing phase, to seal rusted areas.

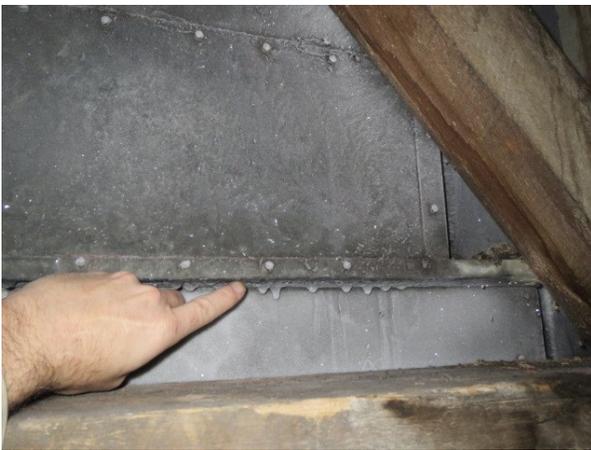
After examining the spires, it is clear that there is a great deal of frozen condensation on the interior surfaces of the galvanized cladding, caused by warm moist air from the occupied spaces below rising into the spire and condensing and freezing on the metal cladding. When exterior temperatures rise above freezing, this condensation will melt and will run down into the condo.

Two conditions are causing the frozen condensation: the constant supply of warm moist air inside the spire, and the fact that the spires have no sufficient ventilation to the outside. So the solution

This is a typical condition of frozen condensation on the back of the sheet metal.

The other condition to control is ventilation. There are some standard louvered soffit vents installed already, but they do not provide enough free area to properly ventilate that much space.

NOTE: sealing the spire from the warm spaces alone will not solve the condensation problem, as the seals will not be perfect. Ventilation must also be added to clear out moist air that will migrate into the space.

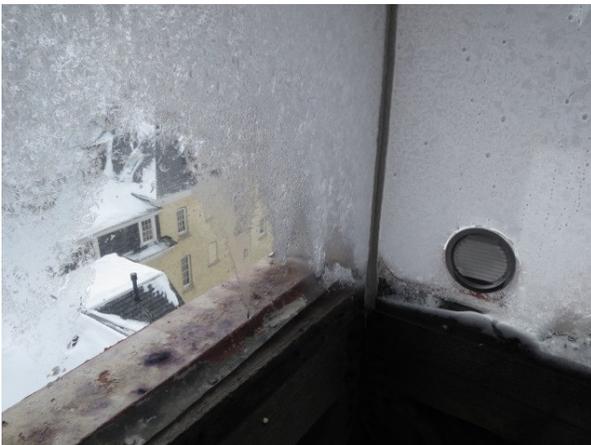
All of the glazing conditions should be reviewed and repaired. 318 had no sealing between the glazing and the structure.
