# TOWER SURVEY

We provided a Survey in January of 2012 based on an interior walk-through. In November of 2013 we surveyed the exterior of the tower from a crane basket. For this current document, I will be building on the 2012 report so you can have a comprehensive summary of all of the issues I have identified in the tower to date.

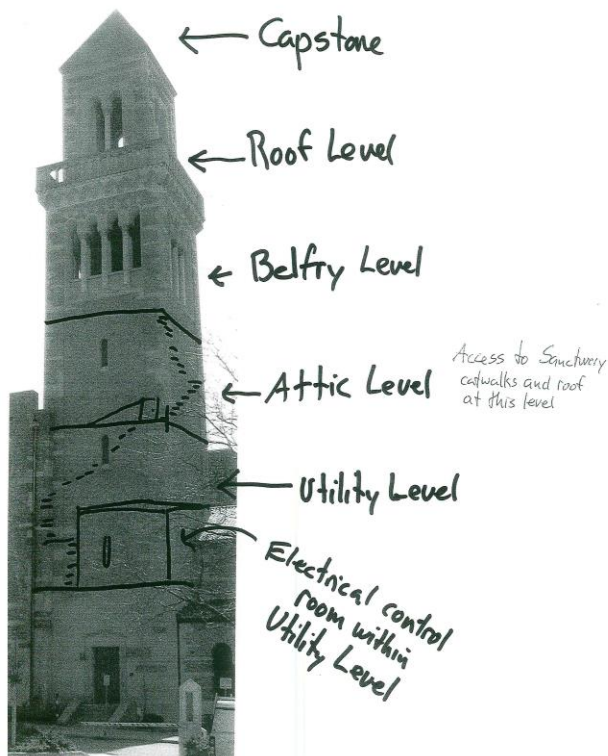
There are five levels as shown in the sketch.

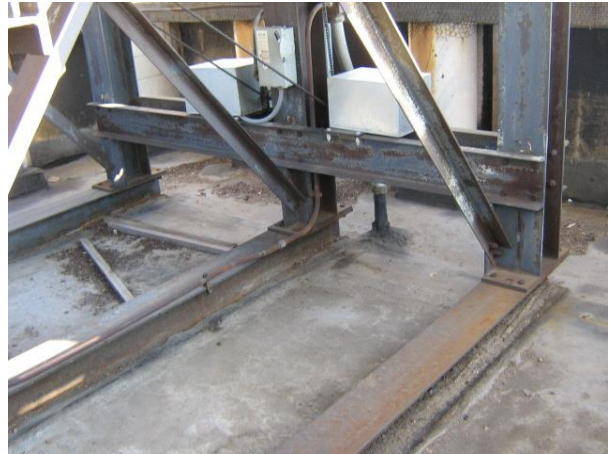
This level houses the bells and is exposed to the exterior. The “floor” is a roof of built-up tar. This flat roof is probably leaking, but is less exposed than the roof above it, so there is less damage. This level is very complicated with many penetrations, obstructions and outlets. The drain outlets are inadequate and clogged by previous repairs.

**3. New Roof at Belfry Level** This flat roof is probably leaking, but is less exposed than the roof above it, so there is less damage. This level is very complicated with many penetrations, obstructions and outlets. The drain outlets are inadequate and clogged by previous repairs. It would be a good idea to clean up this floor and apply some more tar until it can be replaced and perhaps paint the steelwork for the bells. I have guessed at a budget of \$30,000 for this work, but I want to have other roofing specialists look at it.

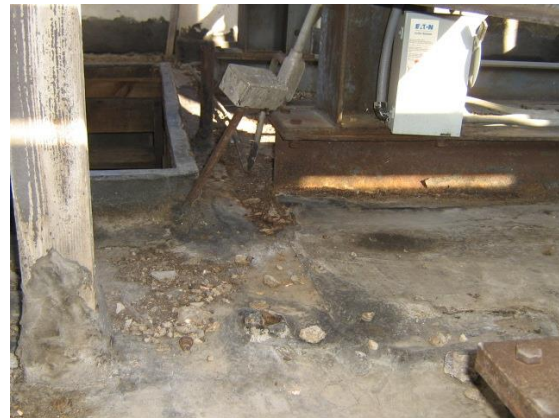
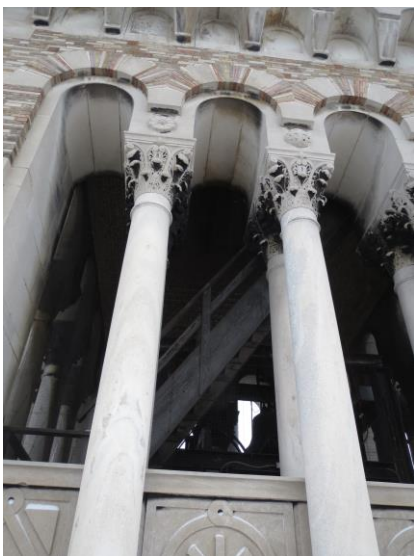
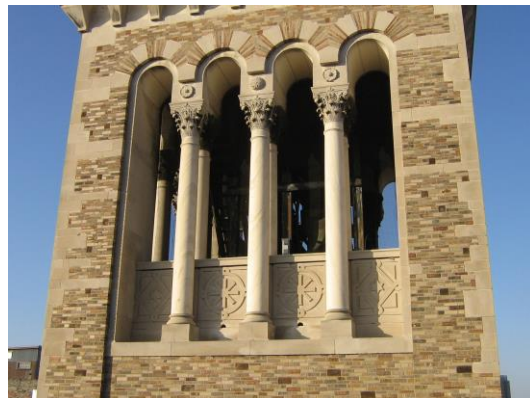
There are three paired limestone columns on each side with ornate carved limestone capitals, and carved limestone panels forming a low wall between the column pairs.

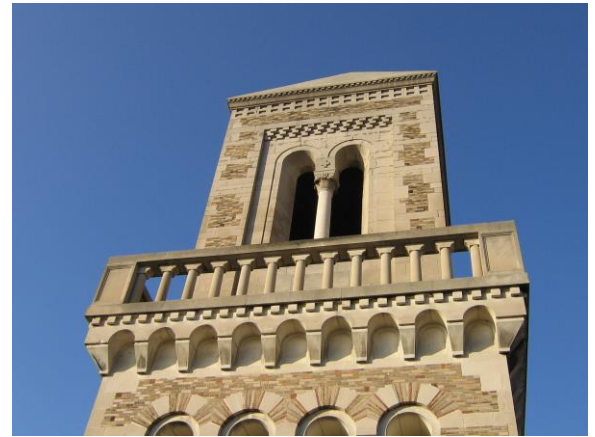
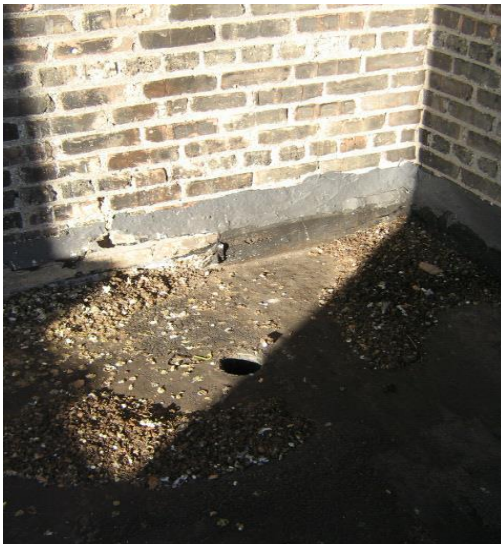
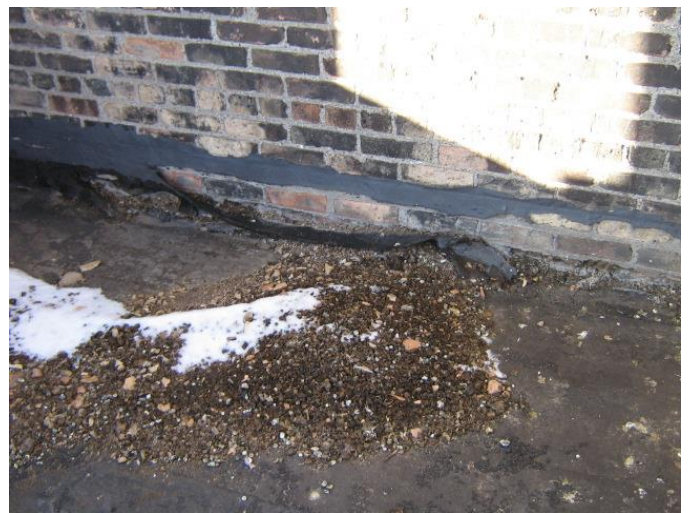
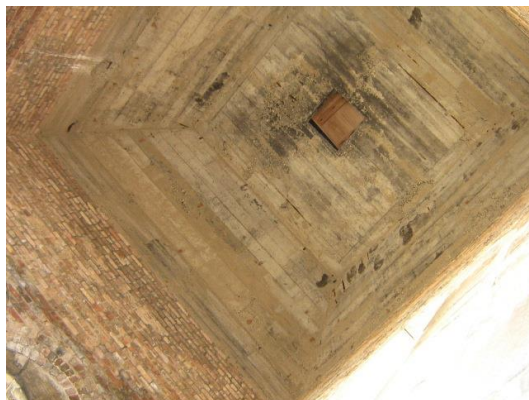
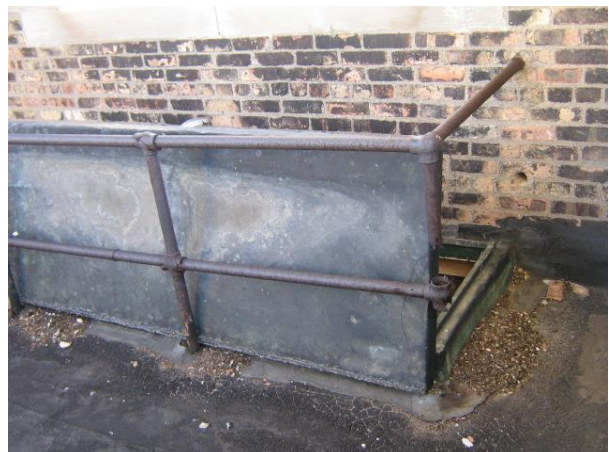
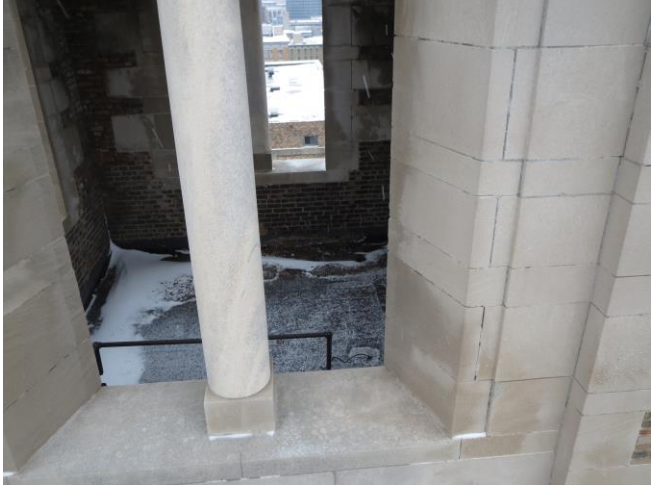
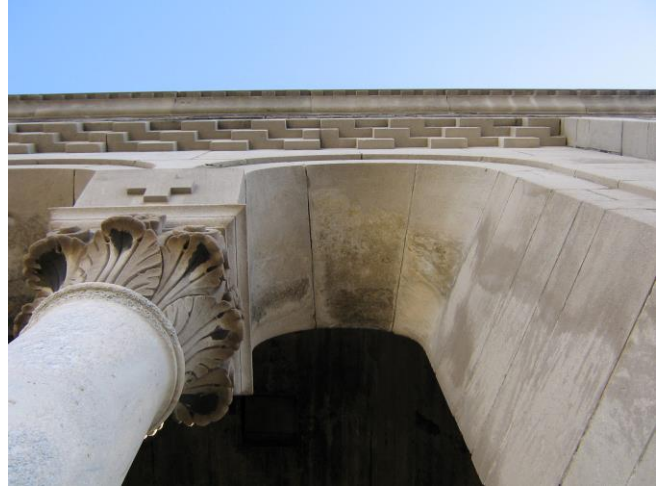
The roof level is surrounded by a limestone balustrade, and is open, without screening. The area inside is open and empty. The roof surface is tar applied over a woven membrane. It appears to be original, with perhaps additional tar applied later. It leaks around the perimeter and is letting water into the masonry wall below. Water and efflorescence is visible on the wall at the top of the Belfry level from these leaks.

There is a single limestone column on each side with an ornate carved limestone capital.

**2. New Roof at Roof Level** The roof surface of the top level is tar applied over a woven membrane. It appears to be original, with perhaps additional tar applied later. It leaks around the perimeter and is letting water into the masonry wall below. Water and efflorescence is visible on the wall at the top of the Belfry level from these leaks. This roof needs to be replaced. This roof drains through one 4" or 5" hole, which drains straight on to the Belfry level below (there were downspouts at one time).

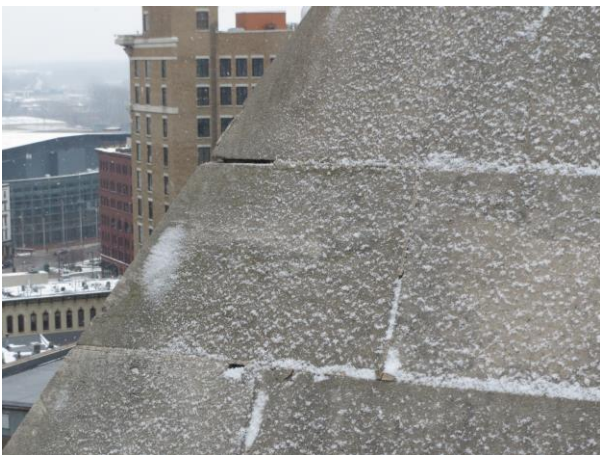
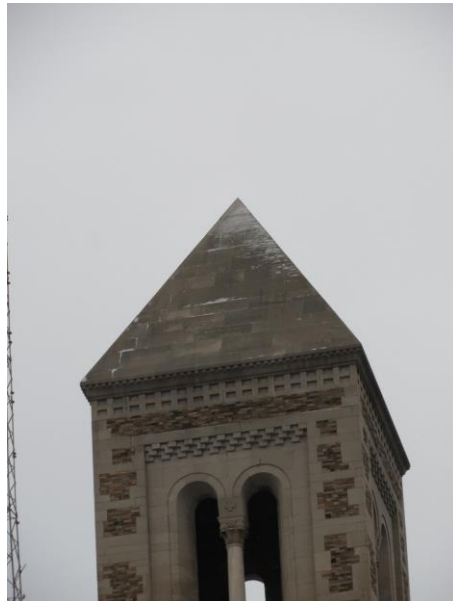
The capstone is made from limestone slabs which are supported by the pyramidal poured concrete substructure visible as the ceiling of the Roof Level.
