INTRODUCTION

***** Property Management contacted me about problems with spalling bricks and failing brick window sills. Bob ***** and I walked the roof and the perimeter of the building. We also reviewed the brick sills from inside an empty unit. This Assessment intends to provide an analysis of the conditions, an approach to the repairs, and a budget. While initial conversations included window restoration work, I understand that that aspect of the work is on hold.

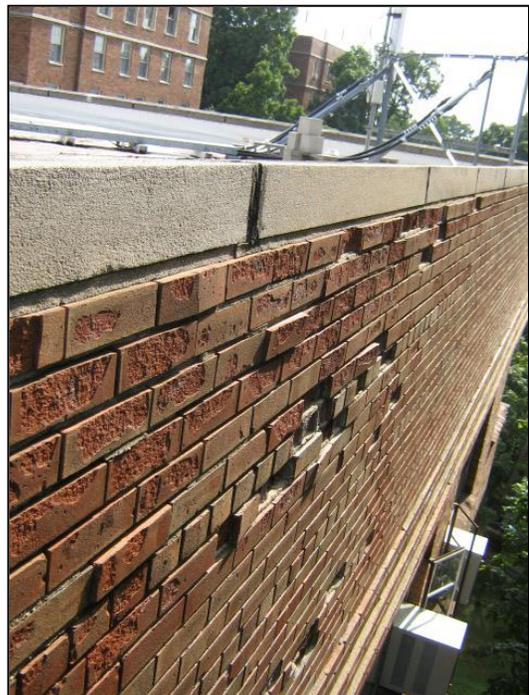
Broken wall bricks are visible mostly on the south side, and near the top. Some areas, as above the upper deck, are extensive and visible. Other areas, as toward the east behind the tree, are spotty and difficult to see from casual observation. I estimate that there are 300 damaged wall bricks on the building, usually in small clusters.

Repairs to the spalling wall bricks involves grinding out the broken bricks and replacing them using new bricks and a softer mortar. This is simple work, requiring only special attention to new brick selection and appearance, and enforcing the use of the correct mortar.

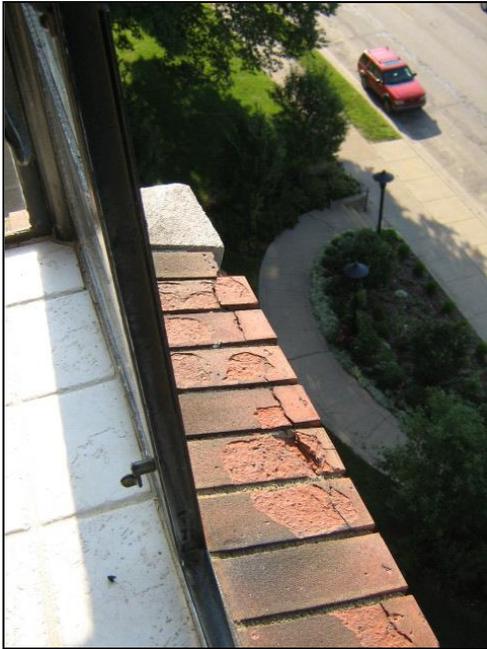
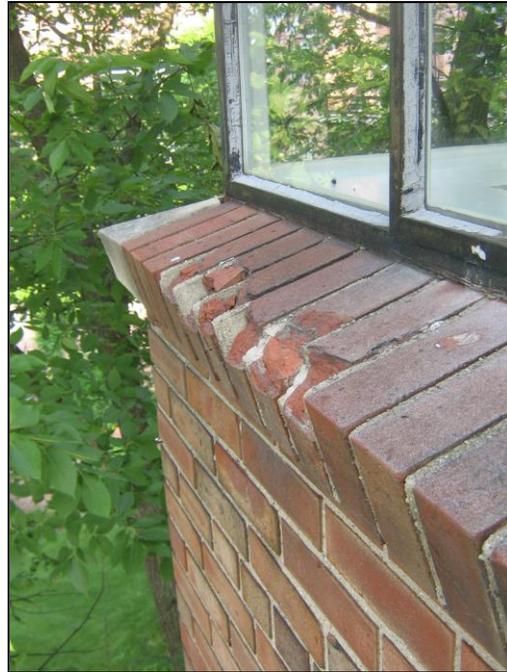
I estimate that there are between 30 and 50 damaged window sills. Some are entirely damaged, while others have only one damaged brick. This is also more prevalent on the south side.

The window sills present three options:

1. Rebuild damaged sills with new brick and softer mortar. This will repair the damage, but not prevent future damage to repaired or unrepaired areas, which can be expected.

2. Replace all of the brick sills with limestone or cast stone (concrete). This eliminates almost all of the sill joints (there would still be some), and would alter the appearance of the building. According to the Historic Preservation staff, this change would need to be approved by the Commission; using brick-colored cast stone would make it easier to get approval.

3. Rebuild damaged sills with new brick, then cover all sills with metal. This repair would almost certainly prevent any future damage, and would be approved by Historic Preservation staff. There may be an already-broken brick or two that could still fall after the metal was installed. The bricks would be inspected before the installation of the metal, but there couldn't be a guarantee.

Given the access costs, I do not recommend repairing the brick sills without replacing the entire sill. The undamaged bricks on a damaged sill will soon fail.

Undamaged sills should be covered with metal. Sills that appear sound should be carefully examined by a competent mason to determine if they are loose or have unseen damage. Any marginal sill should be rebuilt. A truly sound sill can be left, and covered with metal.

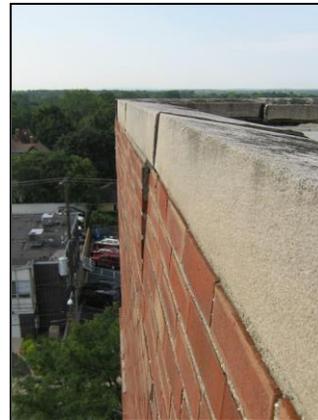
There are some significant vertical cracks in some locations. These usually indicate structural problems such as movement or stress from rusting steel window headers.

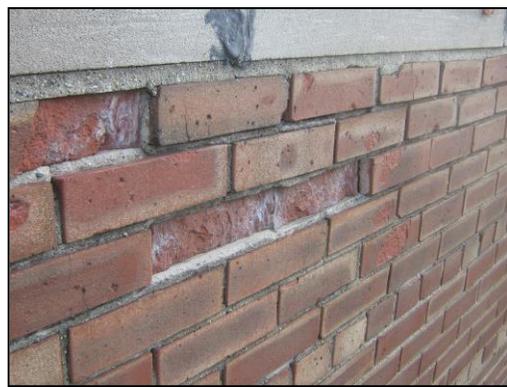
The bricks are breaking apart in a manner called “spalling”. Spalling is

caused by moisture in the brick creating hydraulic pressure as it tries to leave, or by the moisture freezing. Ideally, the mortar between the bricks acts as a matrix to help channel the moisture away from the brick. Mortar varies in strength, and harder mortars tend to not wick moisture very well. If a hard mortar is combined with a softer brick, spalling can become chronic in the right conditions, which is what I believe is happening on the *****: hard mortar, soft bricks, too much moisture. The remedy is to eliminate as many of these factors as possible.

There are no comprehensive remedies for two of the factors: hard mortar and soft bricks. However, during repairs, a softer mortar should be used for all future work.

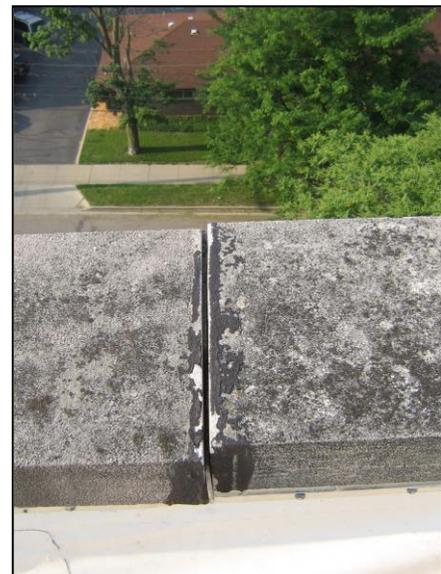
For the window sills, these could be covered with metal. The metal could be a zinc-coated copper, which would require no maintenance, is neutral in appearance, and would not stain the brick below. It would also be essentially invisible from the ground and very likely to be approved by the Historic Preservation Commission.

Covering the sills is a precise task for an experienced sheet metal worker, as a missed or poorly done detail can ruin the work. The joints must be soldered, the right kind of fastener must be properly installed, the details of the caulked window frame transition must be precise, and so on.
